PCB INTERIM MEASURES PLAN

University of
Massachusetts

Lederle Graduate
Research Center

May 2012

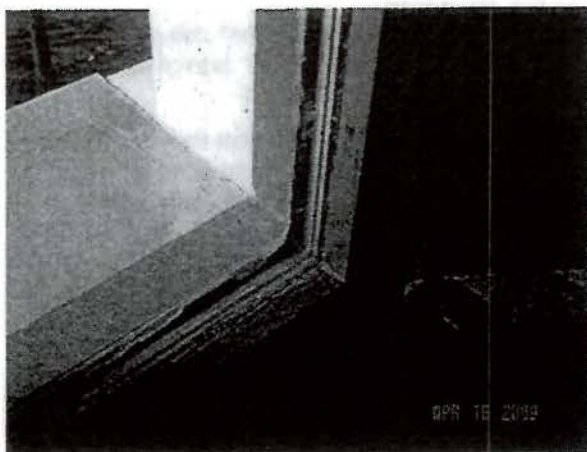
Library Conference Room 365A

Photographs of typical window units are provided below.

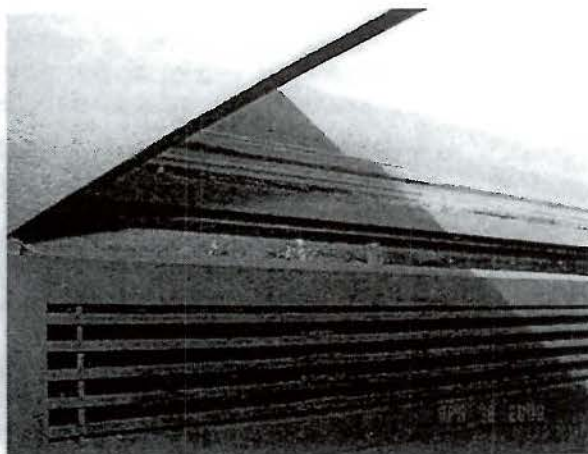
Typical Window Joint with Glazing Sealant

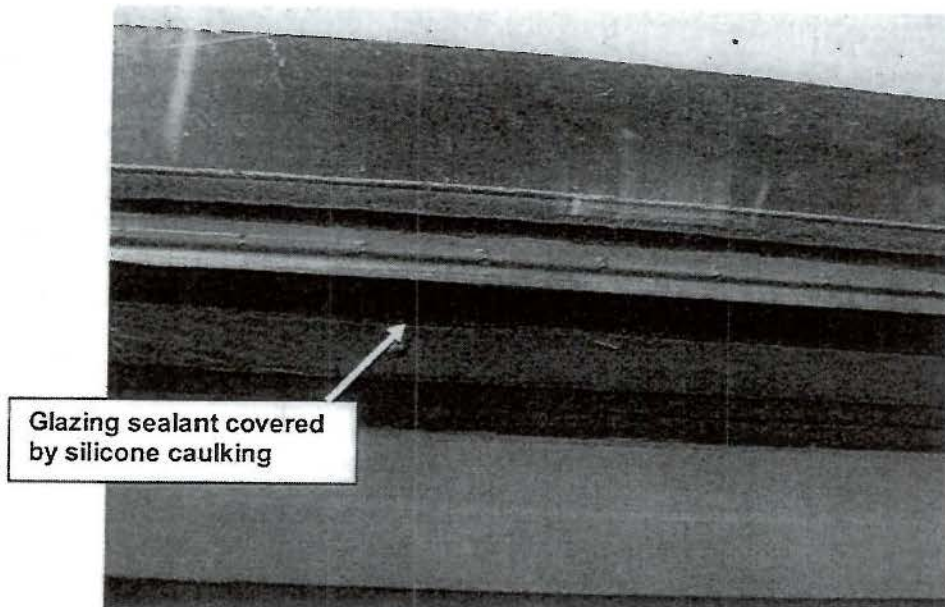
Based on the three evaluation criteria, the silicone sealant was retained for continued monitoring while the Interim Measure approval process was on-going. A photograph depicting the contained glazing sealant by the silicone sealant is presented below.

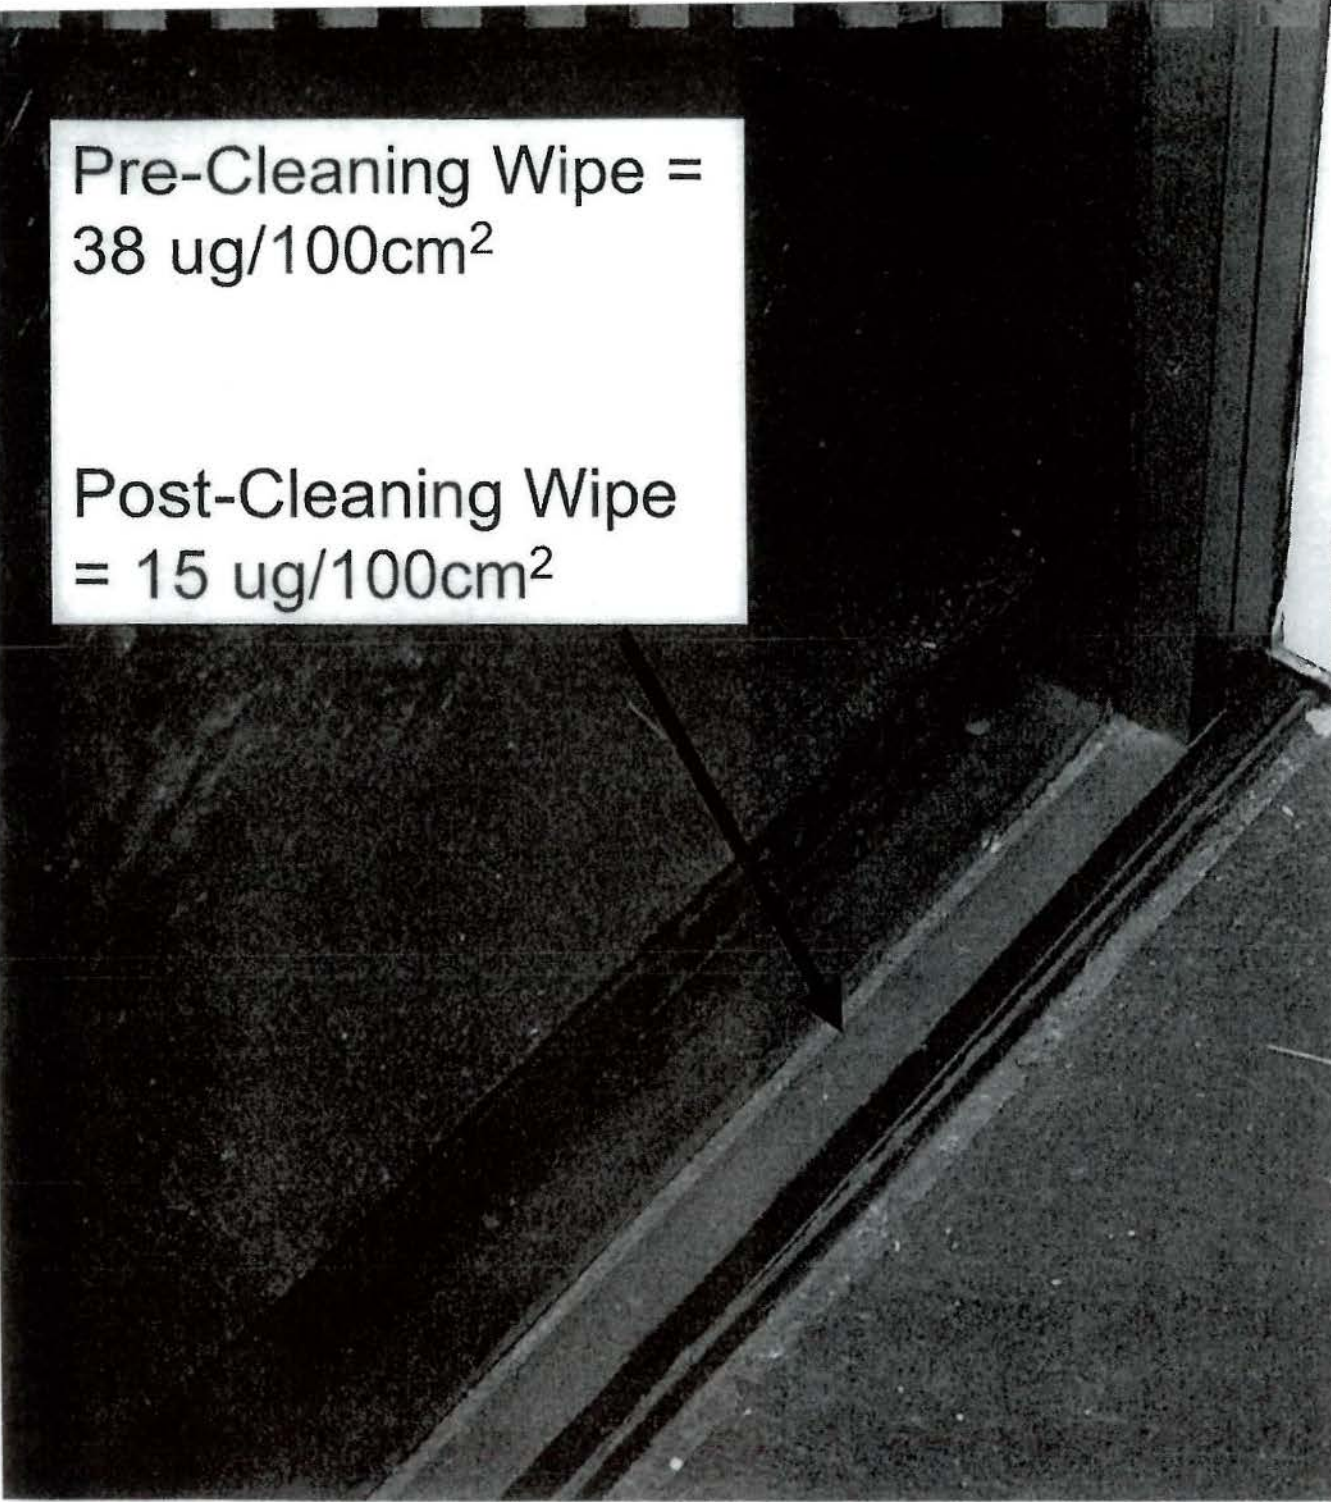
Pre-Cleaning Wipe =
38 ug/100cm²

Post-Cleaning Wipe
= 15 ug/100cm²

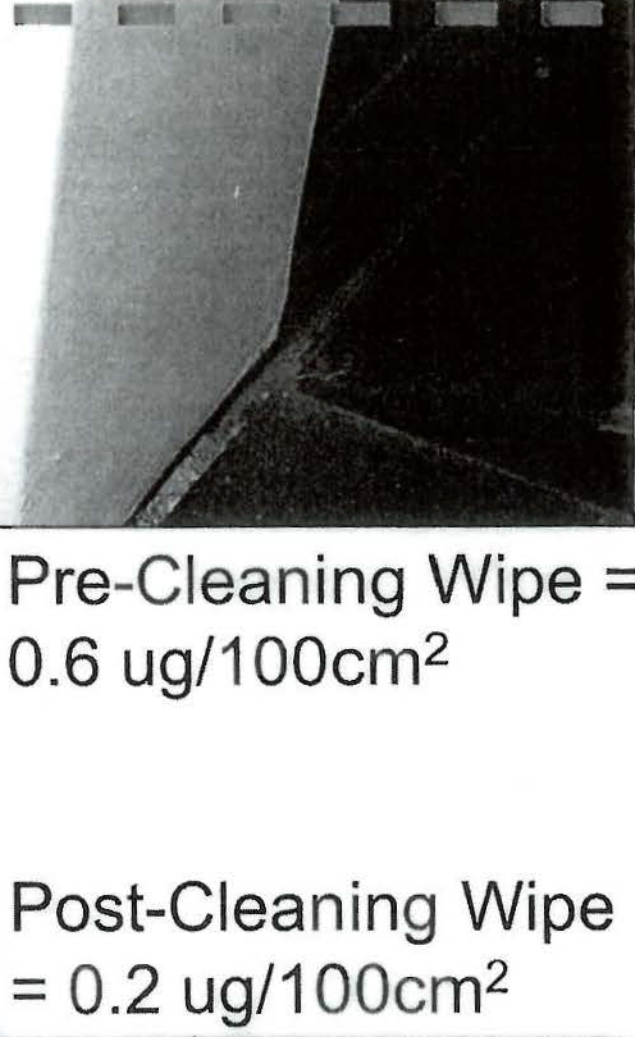
Pre-Cleaning Wipe =
0.6 ug/100cm²

Post-Cleaning Wipe
= 0.2 ug/100cm²
